NASA Technical Paper 1477

# Light Airplane Crash Tests at Three Roll Angles

Claude B. Castle and Emilio Alfaro-Bou

OCTOBER 1979

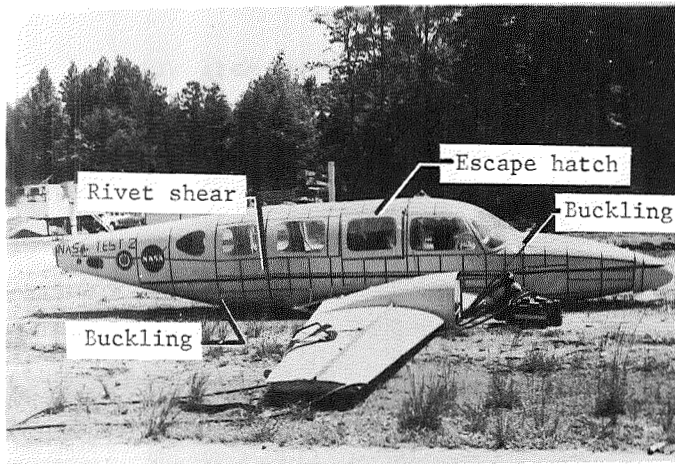
The exterior damage to the airplane for the  $0^\circ$  roll test is shown in figure 10. As seen in the overall view of the right side (fig. 10(a)), buckling occurred in the nose section, at the fire wall, and along the bottom of the fuselage. Rivet shear failure is evident aft from the escape hatch along the window ledge and downward at the rear of the third window. (See figs. 10(a) and 10(b).) Also, rivet failure is shown under the first-passenger window (fig. 10(c)) and across the top of the fuselage aft of the pilot and copilot seats (fig. 10(d)). The breakage of the pilot's windshield and side window occurred because of deformation of the forward cabin section (fig. 10(d)).

(a) Overall view of right side.

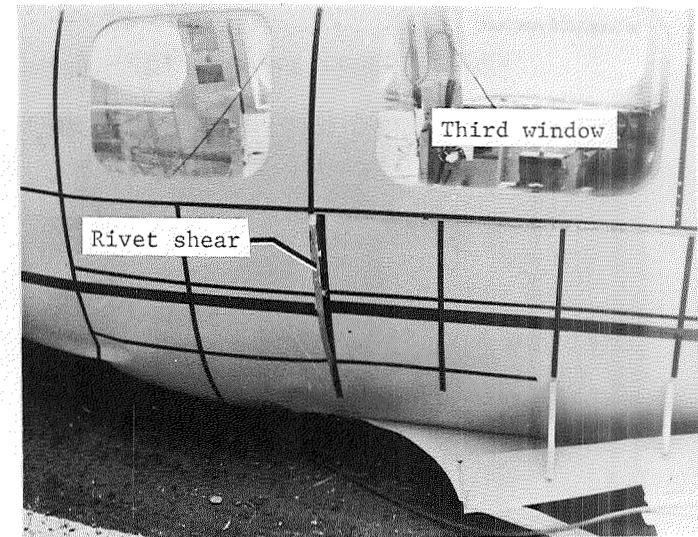
(b) Close-up view of right side.

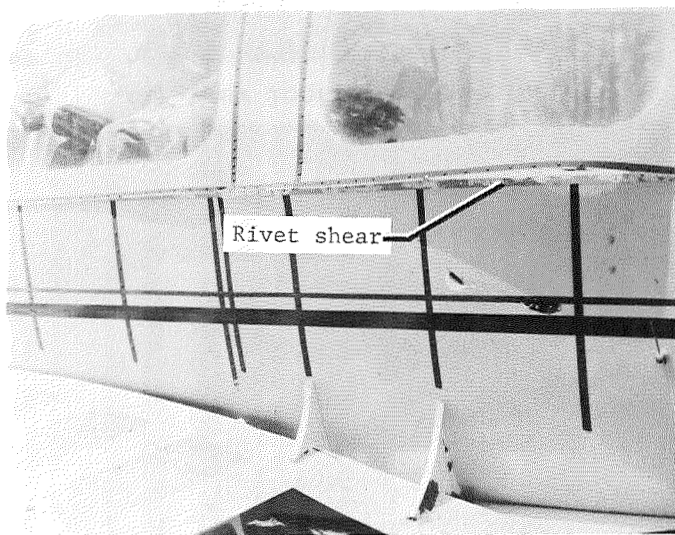
(c) Close-up view of left side.

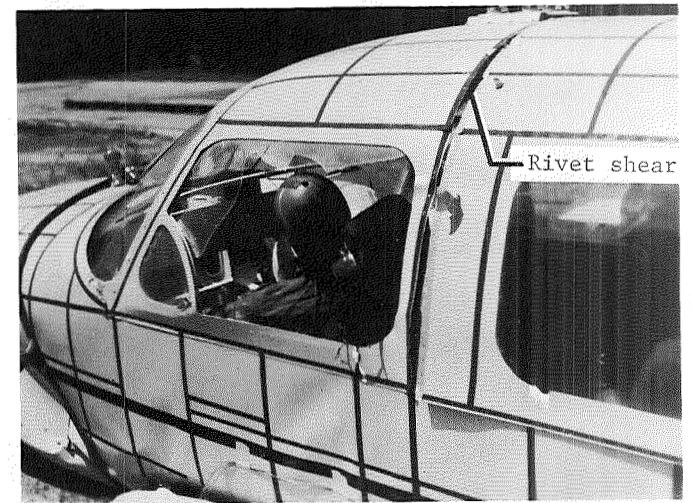
(d) Close-up view of left side and top of fuselage.

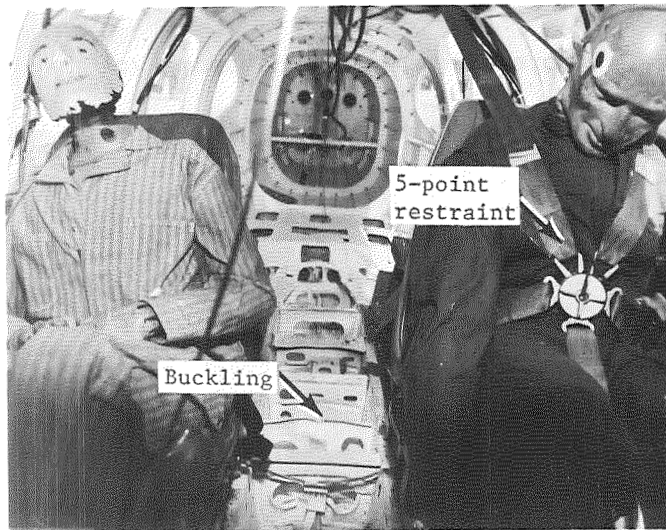
Damage to the cabin interior is shown in the four photographs of figure 11. The first photograph (fig. 11(a)) is a view looking aft from the cockpit, where buckling can be seen in the stiffeners which tie together the two main floor beams. Also shown is the five-point restraint worn by the first-passenger dummy. Figure 11(b) is a view looking forward from the tail section and again shows the main floor beams and the buckled stiffeners. The apparent upward movement of the floor section is shown by the outward rotation of the seats. The four photographs of figure 11 also show the layout of seats, dummies, additional masses, instrumentation equipment, and moderate interior damage.

(a) View looking rearward.

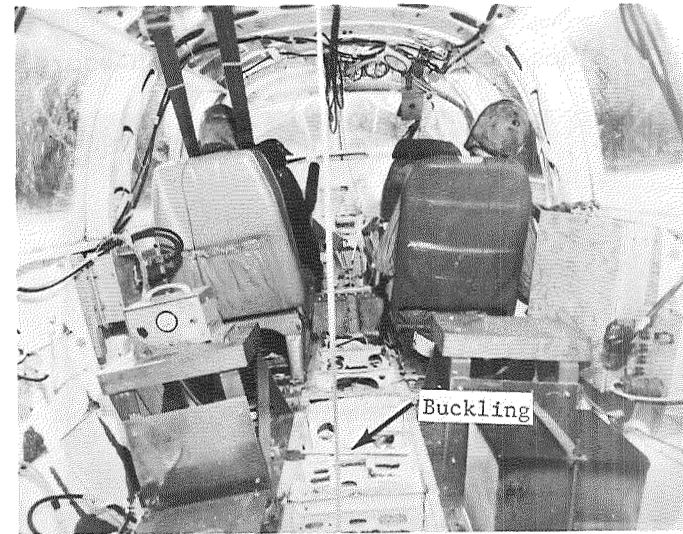
(b) View looking forward.

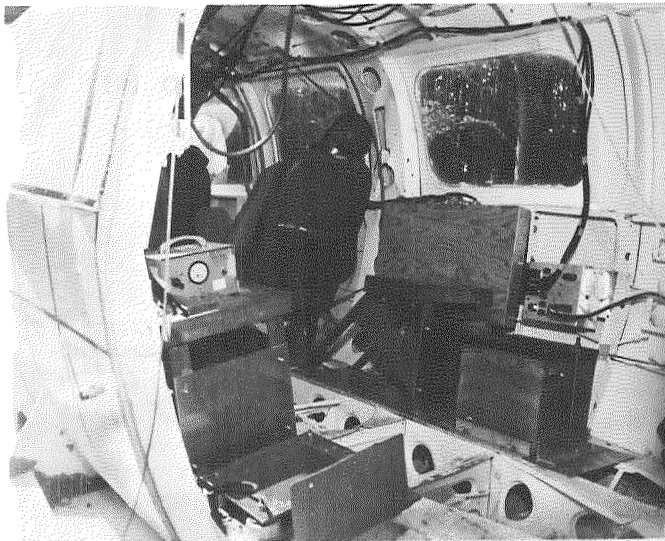
(c) View through doorway.

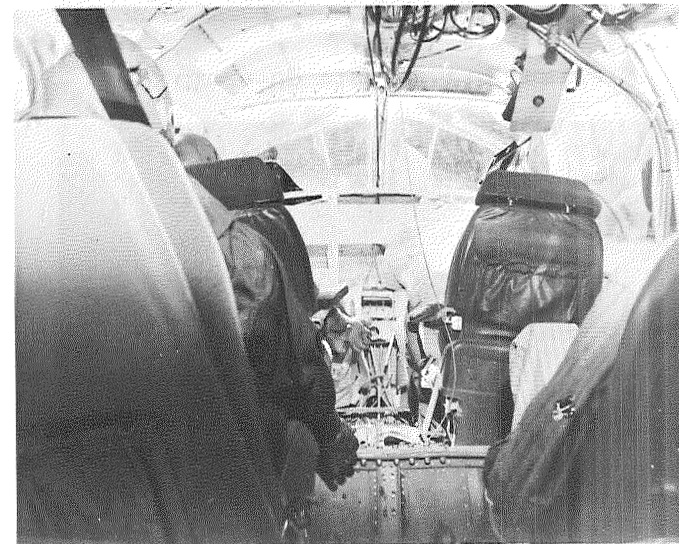
(d) View of cockpit area.

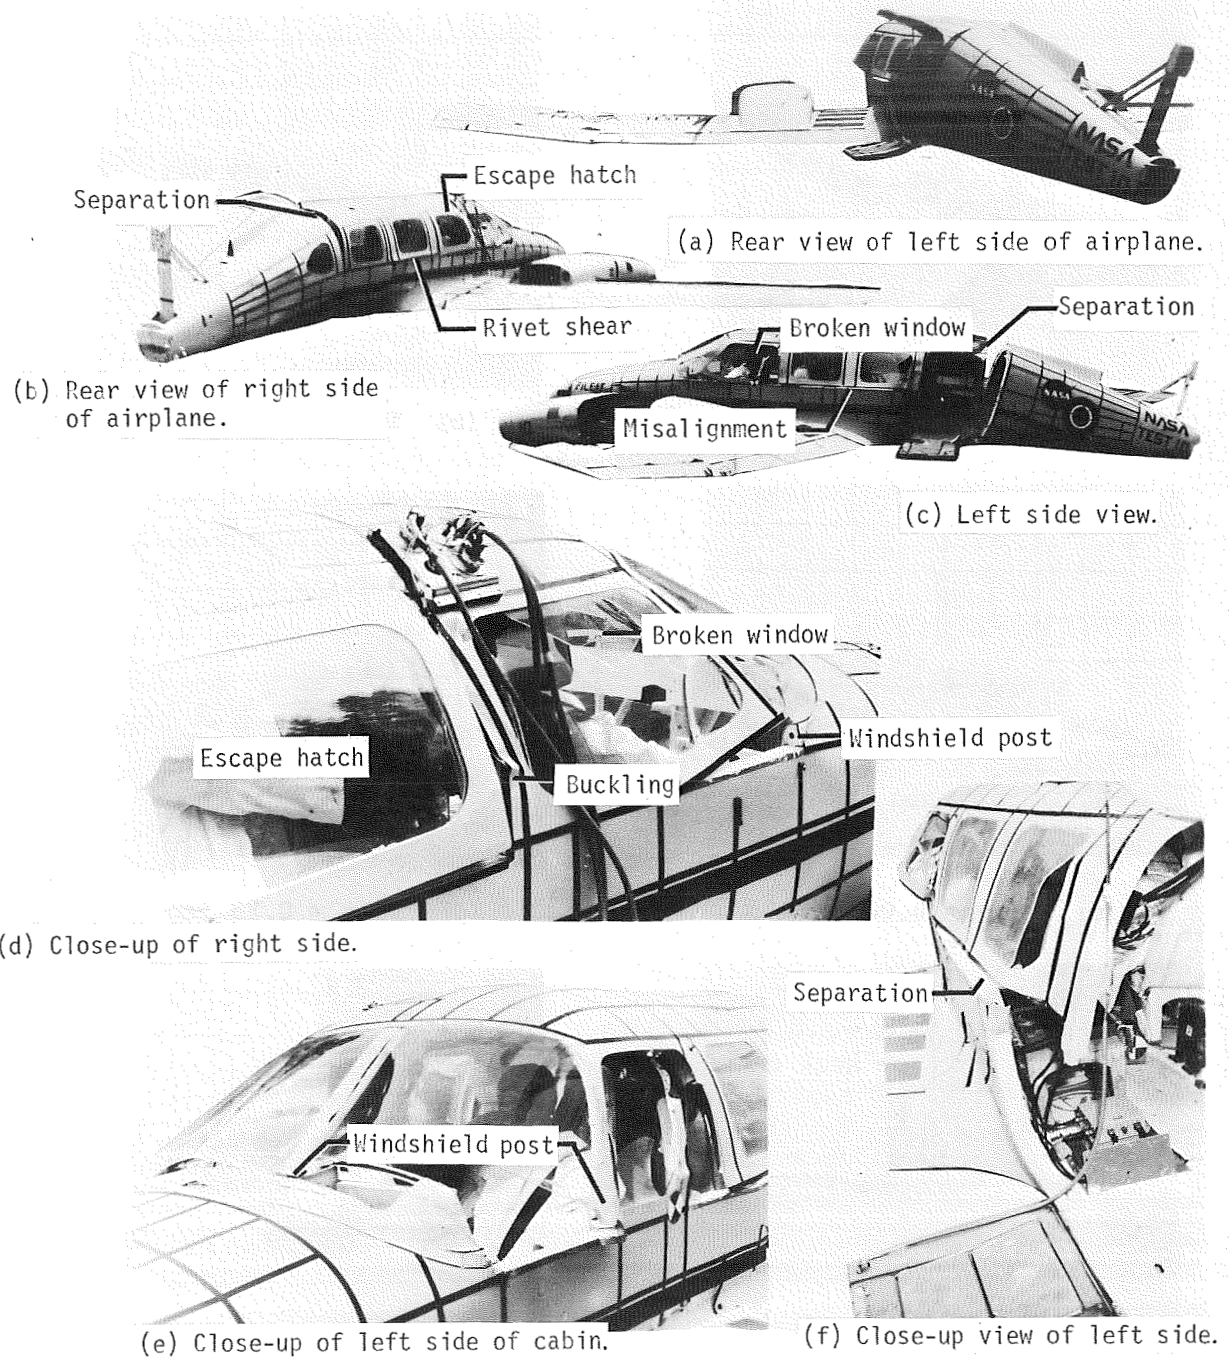
Figure 13.- Exterior damage to -15° test.

The exterior damage resulting from the impact is shown in figure 13. The rear view of the left side in figure 13(a) shows structural damage to the top surface of the wing at about one-third of the wing semispan from the tip. The rear view of the right side in figure 13(b) shows the tail-section separation and loose emergency escape hatch with rivet shear and sheet metal separation under the window frame in the vicinity of the second-passenger seat. A full view of the left side of the test airplane in figure 13(c) shows the damaged wing, cabin and tail separation, broken windows, and the misalignment of the top portion of the cabin. A close-up view (fig. 13(d)) of the right side of the cabin and cockpit areas shows the loosened escape hatch, buckling of the skin, broken copilot side window, and separation and deformation of the windshield corner post. Figures 13(e) and 13(f) show more clearly the damage at the base of the windshield and left side. The deformation across the top of the cabin (fig. 13(e)) and the subfloor crushing did not significantly reduce the livable volume inside the cabin area.

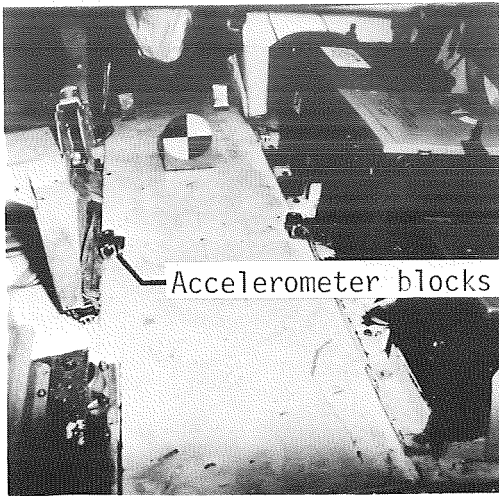
The damage done to the airplane interior in the  $-15^{\circ}$  roll test is shown in figure 14. A view looking forward in the cabin area (fig. 14(a)) shows only a slight apparently upward movement of the center floor area, as can be determined by the outward rotation of the accelerometer blocks. Figure 14(b) shows the forward cabin and cockpit area with fixtures removed. Also evident are slight apparently upward movement of the cabin floor center section and the separation of the cabin along the window ledge. The buckled left main spar near the main spar splice can be seen in figure 14(c), which is a top view of the main spar inside the cabin. A view of the floor support with small amounts of buckling of the cross-support structures is shown in figure 14(d). The torn and separated tail section shown in figure 14(e), in a view aft of the door, shows the effects of tail slapdown during impact.

(a) View looking forward in cabin area with floor.

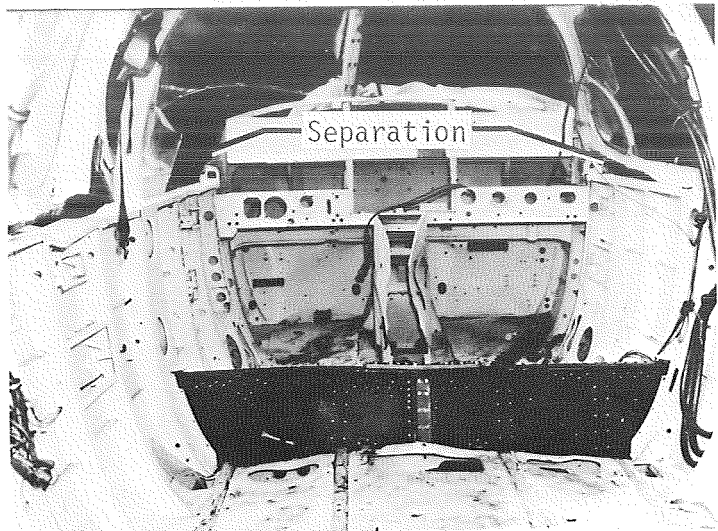
(b) View of cockpit area.

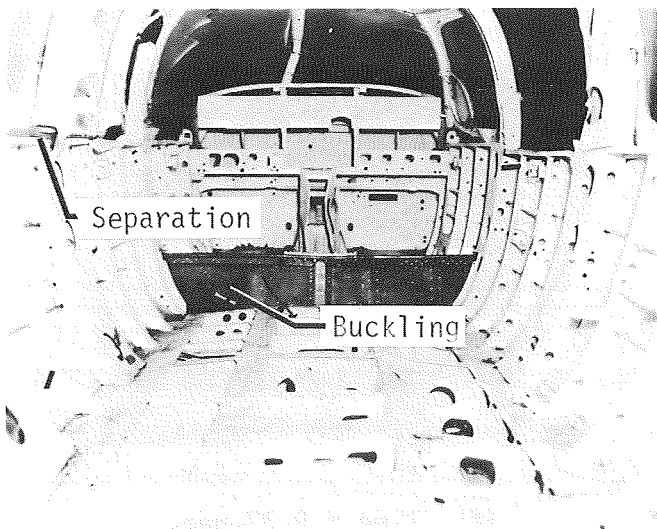
(d) View looking forward in cabin area with floor removed.

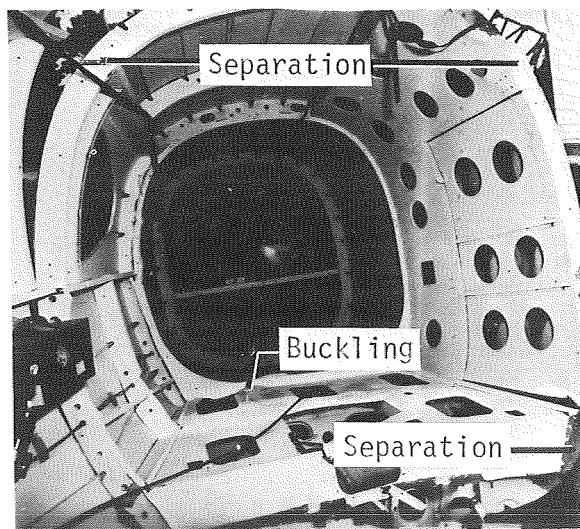
(e) View looking rearward.

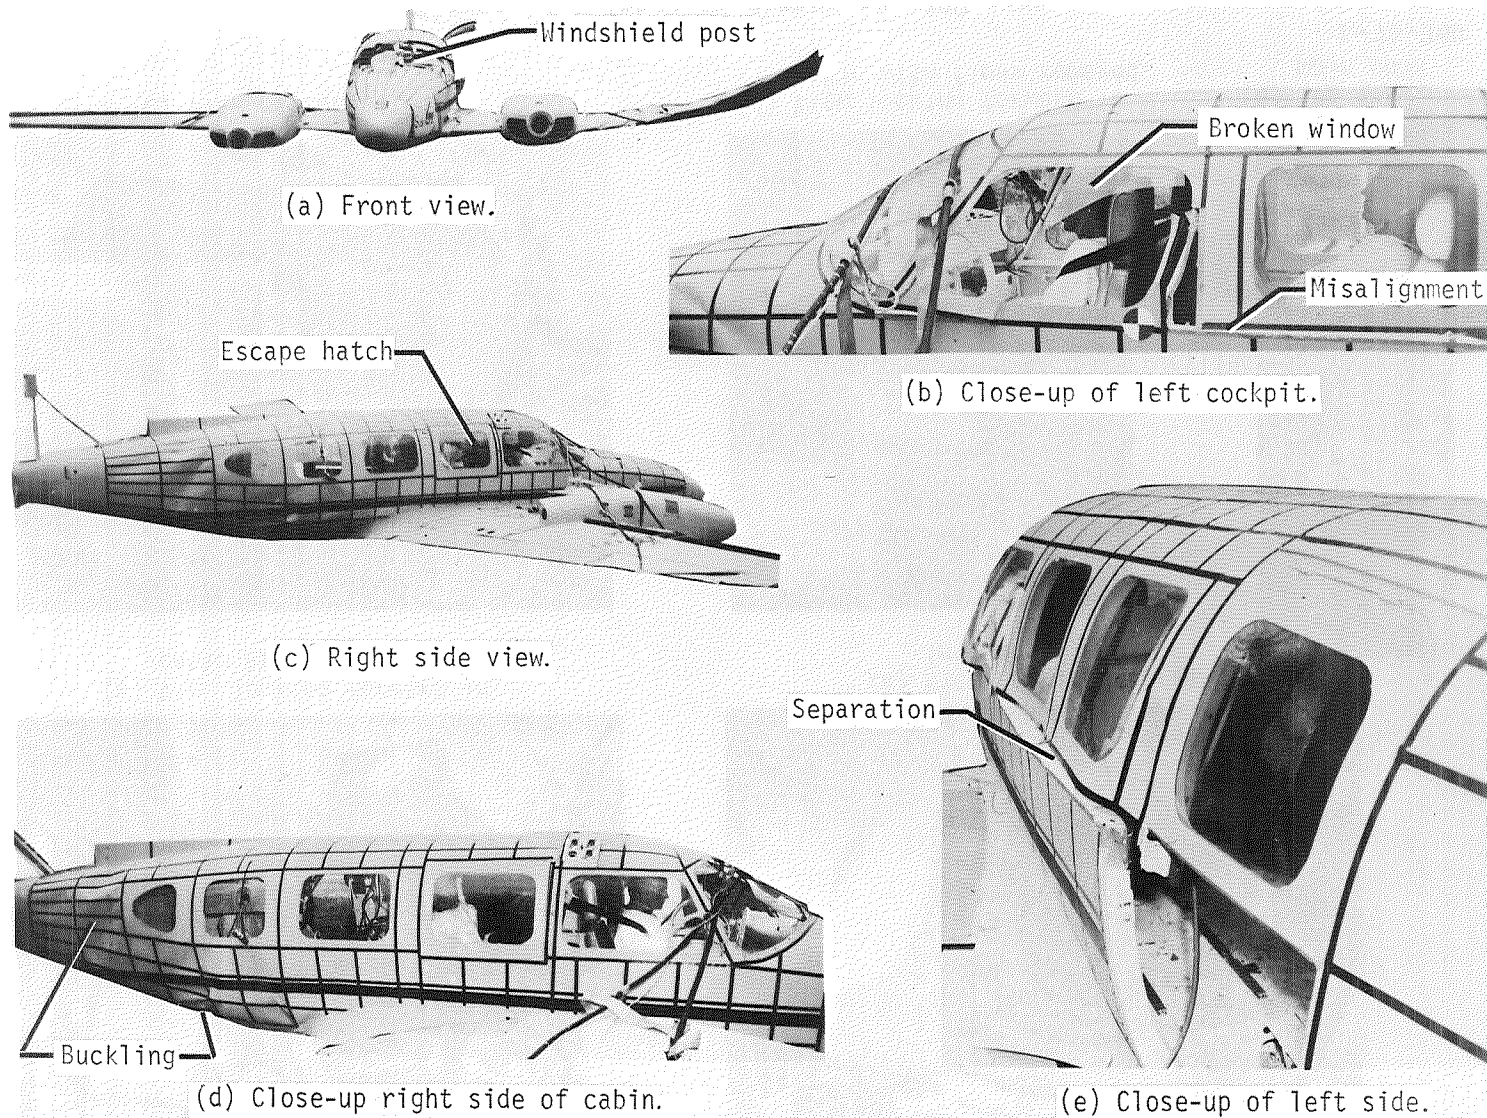
Figure 16.- Exterior damage to -30° test.

The exterior damage to this airplane is shown in figure 16. An overall front view of the airplane in figure 16(a) shows the upward deformation of the left wing and the left and center windshield posts separated at their lower fuselage attachments. The separation of the posts was caused by the tensile load on the top portion of the cabin during tail slapdown. Evidence of the tensile load can be seen in figure 16(b) by the misalignment of the black vertical skin lines (reference lines) between the pilot and first-passenger dummies. In the right side views (figs. 16(c) and 16(d)) skin buckling is shown in the aft portion of the fuselage. A rear view of the left side of the airplane (fig. 16(e)) shows separation of the cabin along the window ledge and misalignment of the painted lines of the underlying airframe sections.

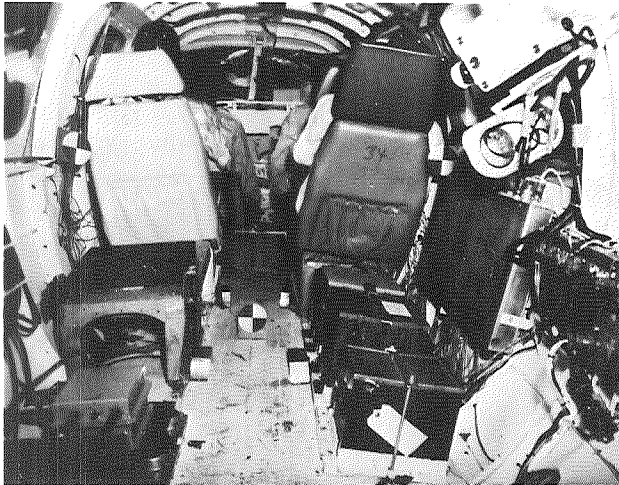
The interior cabin damage in the  $-30^{\circ}$  roll test is shown in figure 17. A view looking forward in the cabin section (fig. 17(a)) shows only a slight apparent rise in the center portion of the floor manifested by the outward rotation of the seats. A view of the rear section of the airplane (fig. 17(b)) shows only minor fuselage separation along the lower portion of the fuselage. The windshield post, pilot side window, and copilot windshield were broken and are shown in figure 17(c); also shown is a slight buckling of the main spar. Damage to the cross members between the floor beams is shown in figure 17(d). Damage to the main spar is shown in a top view in figure 17(e).

(a) View looking forward in cabin area with floor.

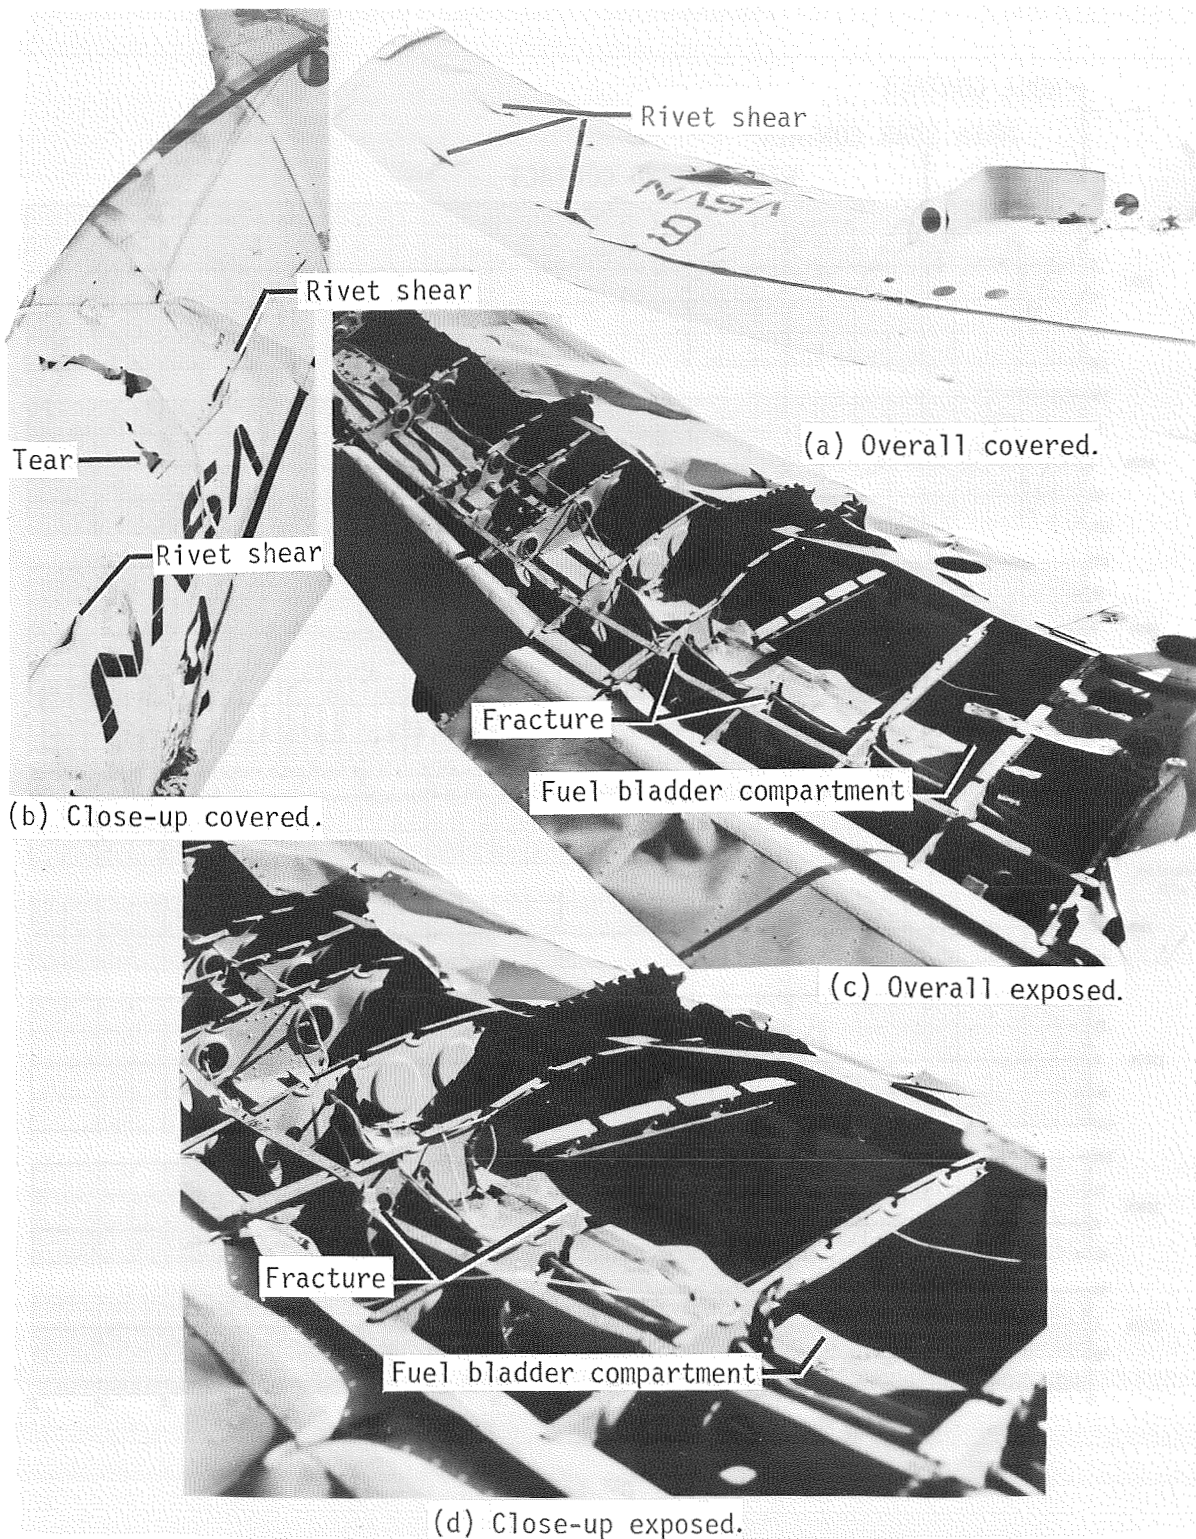
Figure 18.- Damage to left wing in -30° test.

The left wing in the  $-30^{\circ}$  roll test is shown in figure 18 with skin damage evident on the top surface (fig. 18(a)) and with skin tears and rivet shear shown in the close-up (fig. 18(b)). A section of the damaged wing with the upper skin removed is shown in figures 18(c) and 18(d). Rib and rear spar fracture is evident in the close-up view (fig. 18(d)) in the vicinity of the outboard fuel bladder. The broken rib sections punctured the fuel bladder in several places.
